Superintendent Report

May 2026

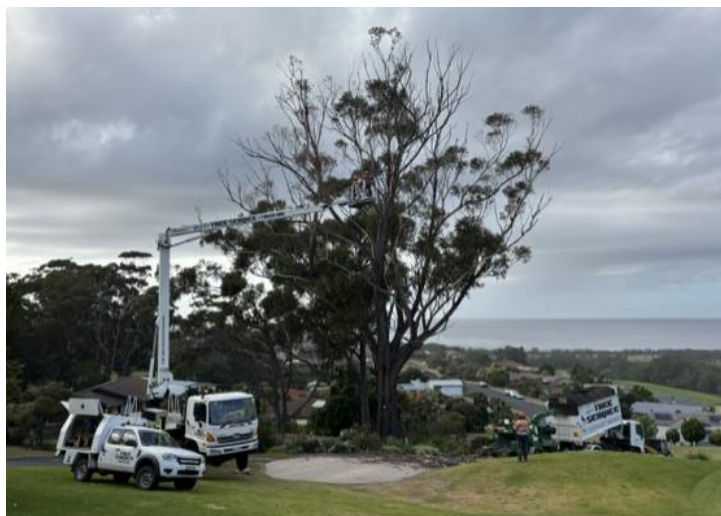
McKill's Tree Service has been on site removing dead and hazardous limbs from the large tree behind the 14th green. This was a complex operation due to the surrounding garden beds, cart paths, retaining walls, and nearby main road. To ensure the work was carried out safely and efficiently, Kane utilised a large elevated work platform (EWP).

The crew has also completed the removal of dead and dangerous trees on the left-hand side of the 12th green. As we move into the winter months, further vegetation management works will continue across the course in similar areas.

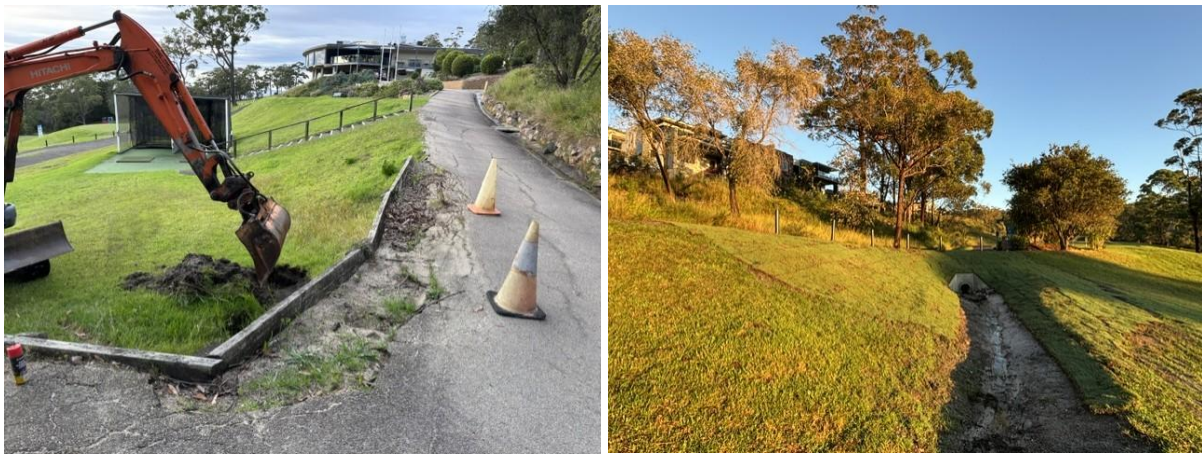
10th Path Embankment

Restoration works have now been completed on the stormwater drain and pathway area leading to the 10th tee. The existing pathway had become unsightly over time, and the drain regularly silted up during heavy rain events.

To address these issues, we extended the concrete pipe and installed a new 375mm headwall. The surrounding area was then reshaped to widen the pathway and improve the contouring around the drain outlet.

The area has been turfed using grass from our couch nursery to help stabilise the soil and prevent future erosion. Couch was selected for this area as it requires less maintenance during the growing season. Given the steep nature of some sections, reducing the need for whipper snipping will improve both safety and efficiency for the maintenance team.
